Riverton Harbour Subcommittee Agenda OPEN

- 1 The purpose of the report is to provide the Riverton Harbour Subcommittee (RHS) with an update on the second Emtech report on the Riverton Harbour wharves. This report covers the level of maintenance that has been undertaken to bring the wharves up to the required standard since the first report was provided to wharf owners in November 2015.
- 2 Further, this report seeks the RHS recommendation to Council that should current licence holders fail to complete the necessary works by 30 June 2019 Council will move to revoke licences and ownership.

On 4 and 5 September 2018 Emtech personnel assisted by Riverton Community Board (RCB) representatives carried out re-inspections on all the structures for which SDC in conjunction with the Riverton Harbour Subcommittee (RHS) have jurisdiction for permitting and licensing. These inspections were undertaken to assess the current condition of the structures and in particular if the recommended maintenance works following the 2014 inspections had been addressed.

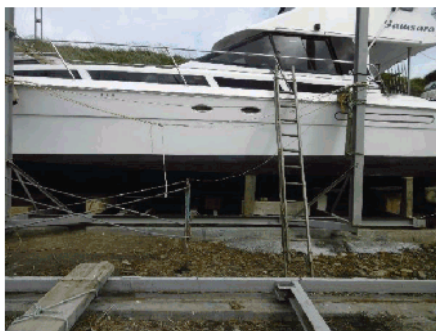
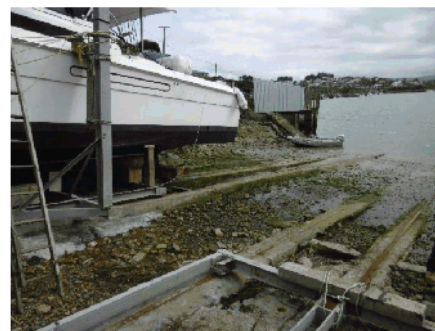
Asset or Berth Number	L02 Slipway	Former Marine Department Reference:	MD 13978
Owners Name	Riverton Slipways C/- Murray Anderson		
Owners Address	67 Towack Street, Riverton 9822		
Asset Details	Asset type: Slipway		
Lease Length (m)	36.92 (L01 combined)	Cradle Length	7.85m
No. of rails	3	Cradle Width	3.47m
Rail Length (m)	30+	Cradle height	4.60m (stanchions)
Width (across rails)	3.26m	Max vessel breadth	4.7m – Between stanchions
Services	Power and water in shed		
Condition			
Foundations & rails	The 2 outside rails are set on 300mm wide footings and both are in good working condition. The centre rail is set on a 700mm wide footing also in good working condition.		
Cradles	Cradle is in good working condition. Associated sheaves, wires and attachments all ok.		
Sheds/Amenities	Amenities are shared with the buildings at the top end of Slipway 1. These house the services and winches for haul-out on slipway 2. Refer notes L01 Slipway.

Previous Recommendations	Address areas of erosion with compacted hardfill to prevent further erosion around rails in short term. Possible use of designed coffer dams to retain fill and limit erosion.		
2018 Inspection	Erosion areas around rails have been addressed. No coffer dams installed to limit future erosion but acceptable as current. Refer also L02 re: equipment shed.

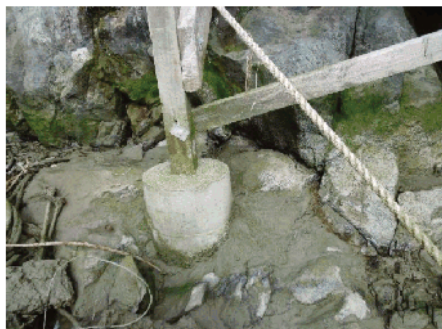
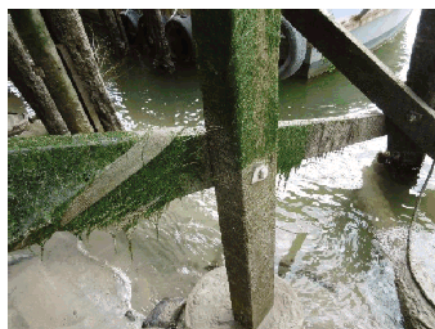
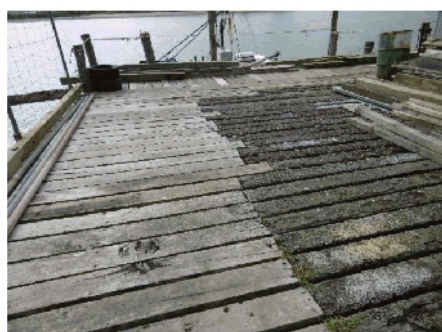
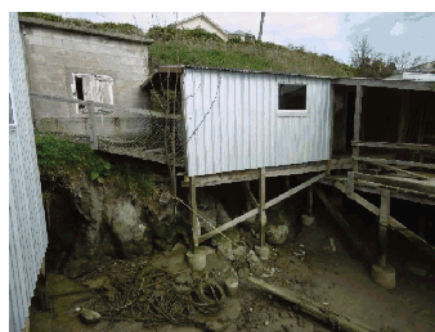
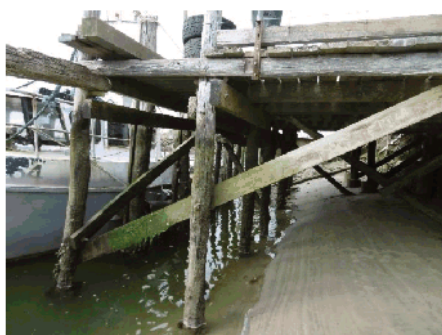
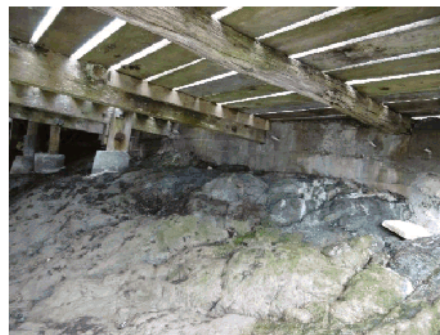
L04

Structure	Where necessary the SW & HW deck beams and Headstocks, including their connections to the piles have been addressed and all appear satisfactory. The bracing was generally in poor condition however almost all braces have been replaced or remediated and additional bracing has been installed. The structure is noticeable better. The additional structure and the walkway to the south east as means of egress from the buildings and wharf was previously lightly constructed, this has now had additional timbers added with bracing and is also much better. Hand railing and connections have been replaced as required.		
Piles	Almost all piles have been concrete collared from below river bed level to approx. 300mm above bed level. This has addressed areas of noticeable wastage in the piles and ensured the structure is well founded.		
Additional info and comments			
Previous Recommendations	<p>The significantly deteriorated bracing elements in the structure will need to be addressed within the next 12 months. The majority will require replacing. In doing so, if a pile is found to have significant wasting at the existing fixing location, the pile itself will be required to be replaced.</p> <p>All handrails require adequate fixings to be installed to the structure. 2-M12 galv bolts minimum bottom fixing of stanchion at 1.5m crs max.</p> <p>30% of the deck planking requires replacing (6-12 months)</p> <p>To reduce deflection of structure around the stairs additional strengthening or bracing of the substructure and connection to piles is required. (6-12 months)</p>

2018 Inspection	All areas from previous report addressed

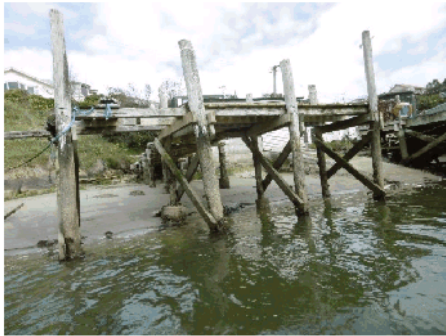
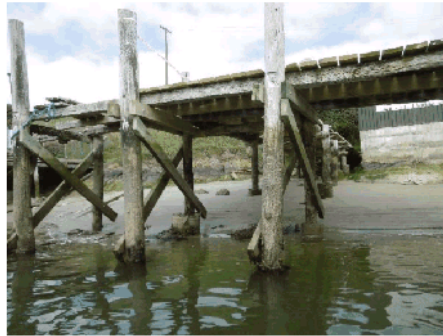
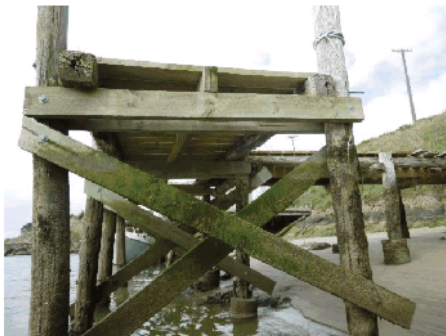
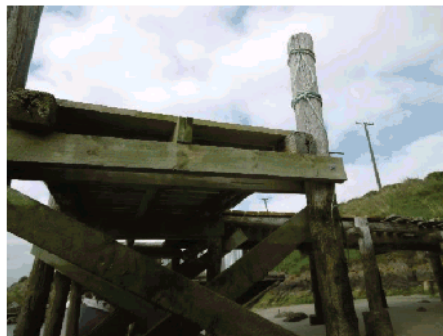
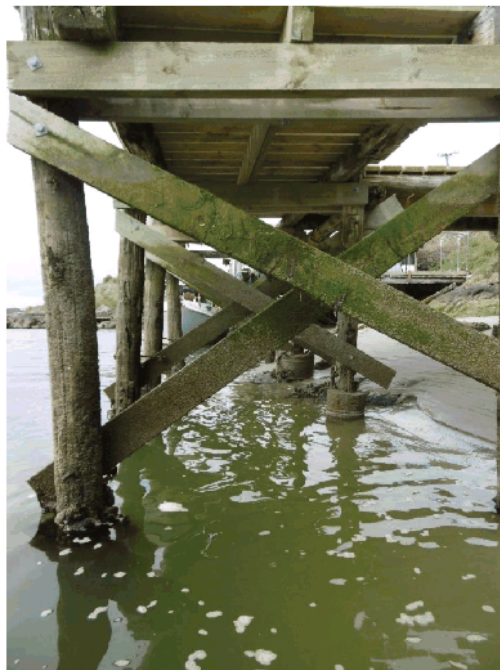
Asset or Berth Number	L05	Former Marine Department Reference:	MD 12622
Owners Name	W B Corbin		
Owners Address	84 Milton Street, RIVERTON 9822		
Asset Details	Asset type: Wharf structure		
Lease Length (m)	16.92	Decking	200x50 SW at 250mm crs
Structure Length (m)	7.9	Deck Beams	Outside beams 180x180 HW Inner beams 150x75 SW
Both sides Aval.	No	Headstocks	Varying sizes All unacceptable condition
Total Berthing (m)	7.9	Piles	200dia HW at 2.5m crs
Width (m)	2.4	Bracing	Varying sizes – All poor
Additional Areas	15.2 x 2.6m approach	Fenders	No
Services	No	Bollards	No
Condition		Handrails	No
Deck	Deck planking issues have been addressed on the approach and the upstream leg of the T-head to effectively make an L-shaped structure. The downstream leg of the T-head had a single strand of danger tape across as there was no deck planking beyond this point.		
Structure	<p>The T-head structure was in poor condition at previous inspection, however selected beam, headstock and bracing timber replacement, including new bolted connections has improved this to an acceptable level under the upstream section. The deck beams on the downstream section are still in poor condition however this is the yet un-decked section. Bracing in this section has been upgraded however.</p> <p>The approach structure is generally in acceptable and serviceable condition but there were still some connections on the approach that could do with replacement and/or remedial works to ensure it is effective and tight as there has been none of the bracing reinstalled in this area.</p>

Piles	<p>The outer piles have been straightened and with the combination of new headstocks, bracing and connectors, the piles are now considerably better than when previously inspected.</p> <p>The approach piles have been set in concrete plinths and are ok but some fixings to headstocks still need addressing.</p>		
Previous Recommendations	The structure will require re-piling along the berthing face and some inner T-head side piles will need replacing also. The sub-deck structure requires complete replacement including all fixings. The approach is generally ok with just a number of fixings and general nailing to be addressed within 6-12 months		
2018 Inspection	<p>A permanent barrier or handrail needs to be installed if downstream decking is not to be installed. Alternatively, the deck beams and fixings will need addressed and new decking installed in this area.</p> <p>Some fixings and/or bracing addressed on the approach</p>

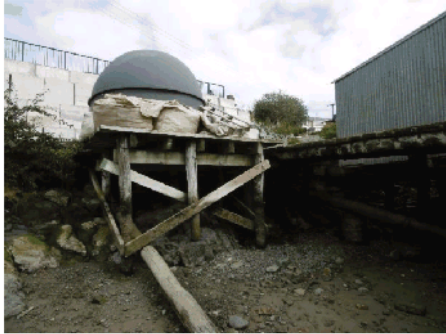
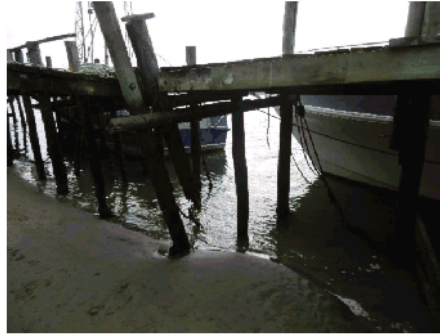
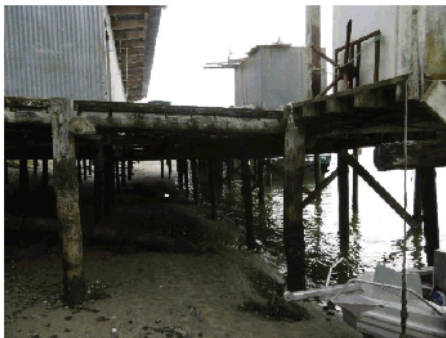
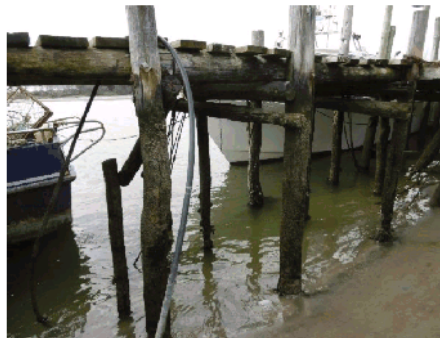
L07

Structure generally good with bracing and fixing under main wharf acceptable, however the bracing and associated fixings under the add-on to the adjacent wharf requires attention. Some braces and 1 pile are poor and may require replacement, as are some fixings which will require replacement.

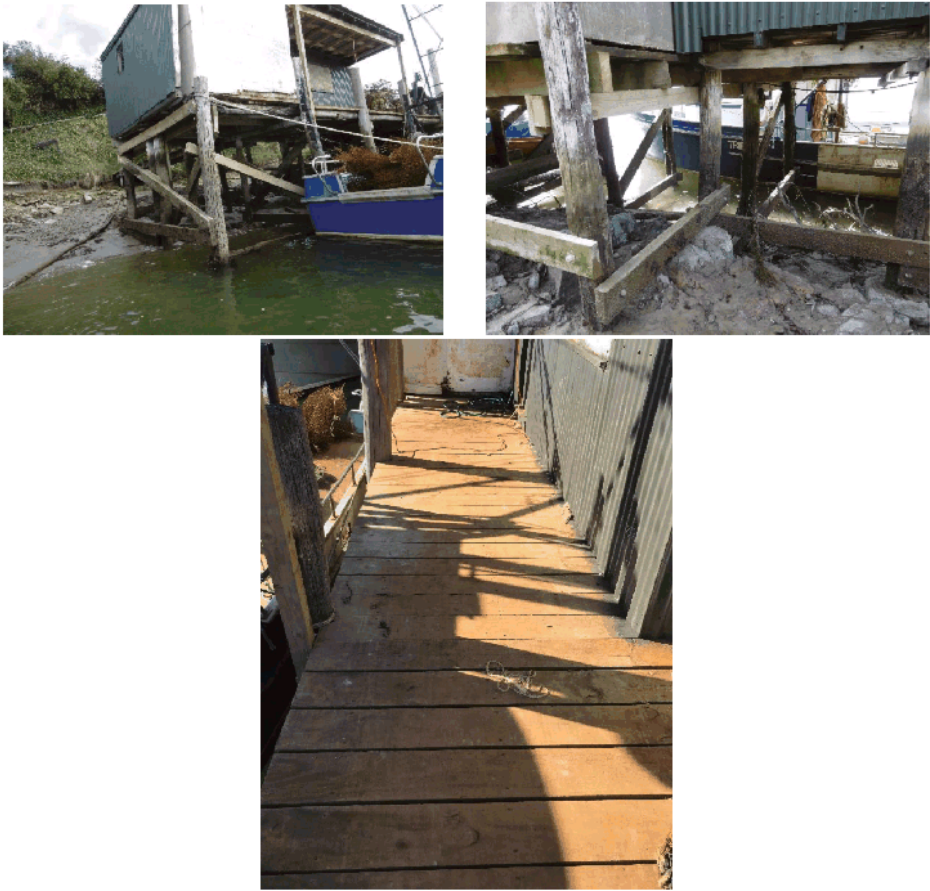
L 14

2018 Inspection	<p>The broken landward trimmer beam requires replacement. We would recommend in this situation that another beam be also installed midway between the broken one and the original landward beam effectively halving the span of the decking and a 150x75 headstock be installed under both fixed with 20dia galv. bolts to the piles to prevent the beam breaking under a modest loads from pots or chiller bins are stacked there</p> <p>The two berthing face piles will require replacing with 200 SED H6 piles</p> <p>All the above work would be expected to be completed within the short term of 6-12 months.</p>
	<p>Decking and fixings replaced as required</p> <p>Berthing face piles adequate</p> <p>New timbers and fixings in structure adequate</p>

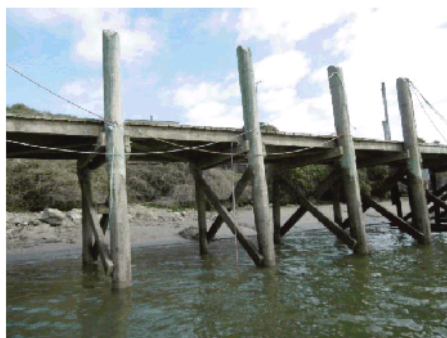
L16

2018 Inspection	Only recommendation would be to apply some bituminous or approved mastic coating to all bolt heads, nuts and washers to ensure you get the required durability. Good installation

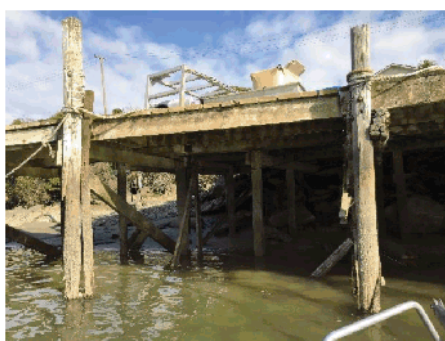
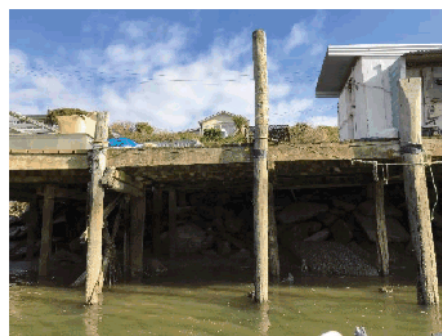
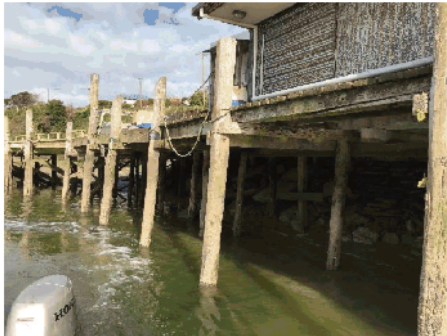
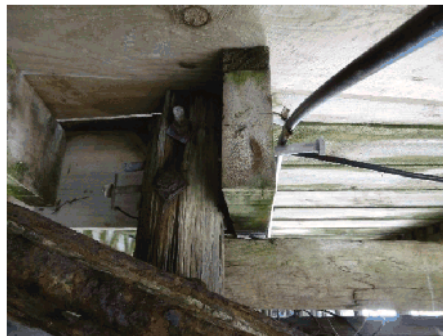
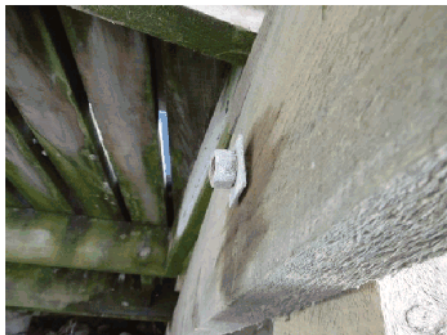
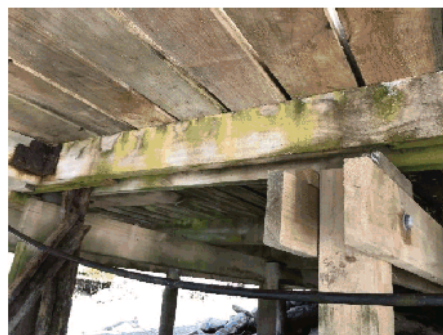
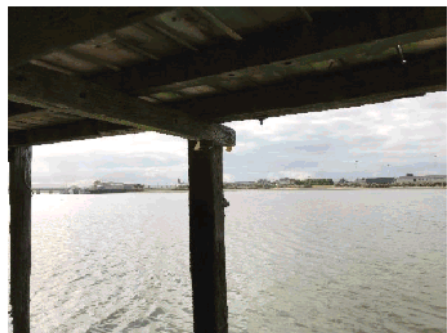
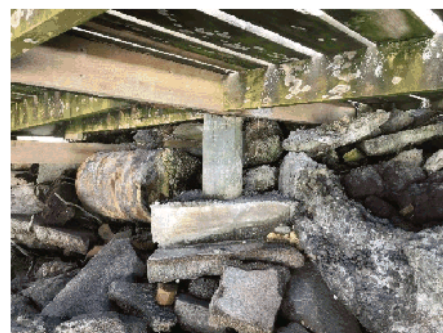
L19

Deck	<p>Original Wharf: The decking is consistent and adequate at the upstream end with 2 planks requiring replacement and general deck fixings to be renewed. The deck deteriorates the further downstream you move with a number of split/broken planks requiring replacement and generally the deck is in poor condition at or around the change in direction of the berthing face.</p> <p>Vehicle Access Deck: The deck area that provides vehicle access to the wharf is constructed with 200-300x50 planks over deck beams only. These have deformed significantly. The deck has no structural integrity in its present form or from its method of construction. This area is unacceptable.</p> <p>Storage Deck Area: This area of decking had newer timber planks but these were already showing signs of deformation</p>		
Structure	<p>The areas of wharf with timber piles, headstocks, deck beam structure are in adequate condition however the areas that have railway iron components are poor and unacceptable.</p> <p>The structure under both the vehicle and storage area decks is poor and showing significant signs of deformation, degradation and is not acceptable. In these deck areas the over-spanning of timber planks and beams, lack of headstocks and no bracing provides no structural integrity to the structure. The use of railway irons in some areas has exacerbated the problem.</p> <p>The structure under the shed is all treated SW and in good condition</p>

Piles continued	<p>tides. The berthing face piles at the wharf change in direction are poor, broken or split and will require replacement</p> <p>The HW piles under the shed are ok although the bolted connections will require attention in the medium term.</p> <p>The piles under the vehicle access and storage deck are light and in poor condition and poorly placed for effective load distribution. These are not attached to headstocks and occur under some beams providing minimal support to the structure as a whole.</p>
Additional info and comments	<p>A freezer/chiller unit is also located on the vehicle access deck against the downstream wall of the shed</p>
Previous Recommendations	<p>The downstream section of this structure is in poor condition and the condition of the wharf, vehicle and storage decks is unacceptable.</p> <p>Four, minimum, new piles will be required at the downstream end of the wharf along with new decking timbers in the short term (6-12 months)</p> <p>The vehicle deck requires the decking timbers to be lifted additional piles placed to suit design loadings and headstocks and deck beams fastened to achieve a structural deck suitable for vehicle traffic expected at this site.</p> <p>The storage deck requires some additional piles or a headstock and beam grid designed and installed appropriate to the loadings it is currently and expected to cater for.</p> <p>The vehicle and storage deck remedial works should be undertaken with some urgency but for practical reasons we have listed them as short term 6-12 months to allow these to coincide with other work on this wharf structure.</p>

2018 Inspection	<p>New piles, and beams have been installed in the vehicle and storage deck areas and the landward side of the structure is greatly improved.</p> <p>Of concern is that a number of bolts were noted as not being done up tight or were missing nuts, washers or both. This needs to be rectified immediately.</p> <p>At least 3 original outer piles have degraded or have been worn extensively and coupled with poor connections to badly deteriorated headstocks provide concern. The piles and headstocks should be replaced or at a minimum the piles and headstocks duplicated. New bolted connections to the headstocks are also required.</p>

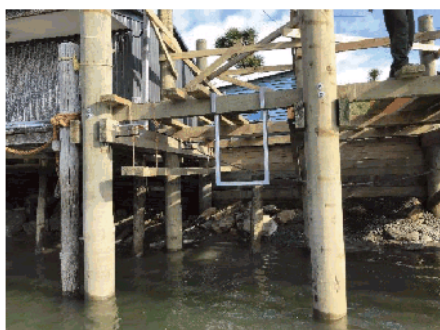
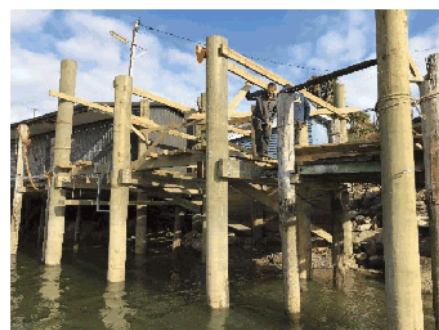
Asset or Berth Number	L20	Former Marine Department Reference:	-
Owners Name	Southern Protein Limited, Russell Keen		
Owners Address	PO Box 19, Stewart Island 9846		
Asset Details	Asset type: Wharf structure and Shed		
Lease Length (m)	9.53	Decking	200x75 at 210mm crs
Structure Length (m)	9.53	Deck Beams	300x100 at 600mm crs
Both sides Aval.	No	Headstocks	2x300x100
Total Berthing (m)	9.53	Piles	250SED HW at 2.9m nom.
Width (m)	2	Bracing	200x75
Additional Areas	4.3 x 2.4m approach	Fenders	No
Services	Power, water & wharf tap	Bollards	No
Condition		Handrails	No
Deck	Existing wharf removed, new treated SW structure		
Structure	Existing wharf removed, new treated SW structure		
Piles	Existing wharf removed, new treated SW structure		
Additional info and comments	Under construction at time of inspection – Progress to date was well built		
Recommendations	Nil

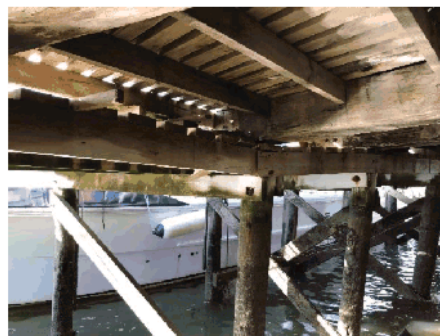
Asset or Berth Number	L21	Former Marine Department Reference:	MD 14742
Owners Name	CA Oswell & AE Hutchings		
Owners Address	10 Carlyle Crescent, Witherlea, Blenheim 7201		
Asset Details	Asset type: Wharf structure and two sheds		
Lease Length (m)	23.38	Decking	200x50 SW
Structure Length (m)	23.3	Deck Beams	200x75 SW
Both sides Aval.	No	Headstocks	200x75 SW
Total Berthing (m)	23.3	Piles	250dia SW
Width (m)	3.1	Bracing	200x75 SW
Additional Areas	Two sheds	Fenders	2 timber fender strips on berthing piles
Services	Power and water	Bollards	No
Condition		Handrails	No
Deck	While we were not able to get access to the wharf structure the deck was able to be viewed from adjacent structures and from the underside. The decking timber is in good condition although it is sloping in areas due to pile movement. Decking timber in sheds all appear ok from underside.		
Structure	<p>The structure has been designed and built solidly with adequate bracing. The wharf appears to have been subjected to a lot of use and in particular berthing loads and impacts. The bottom connection on as many as five of the downstream braces on the berthing face piles have failed. This in turn has let the pile toes move away from the structure most likely as a result of berthing impacts higher up the pile. It is very obvious this structure has been subjected to these impacts as the vessel's beltings have worn the piles and ends of headstocks and braces back in some cases to the extent of exposing fastenings. At least one headstock has been completely broken as a result of the berthing impacts. Sacrificial fender timbers appear to have been fixed recently to mitigate the wearing of the piles</p> <p>The structure supporting the sheds is very solid and in good condition</p>

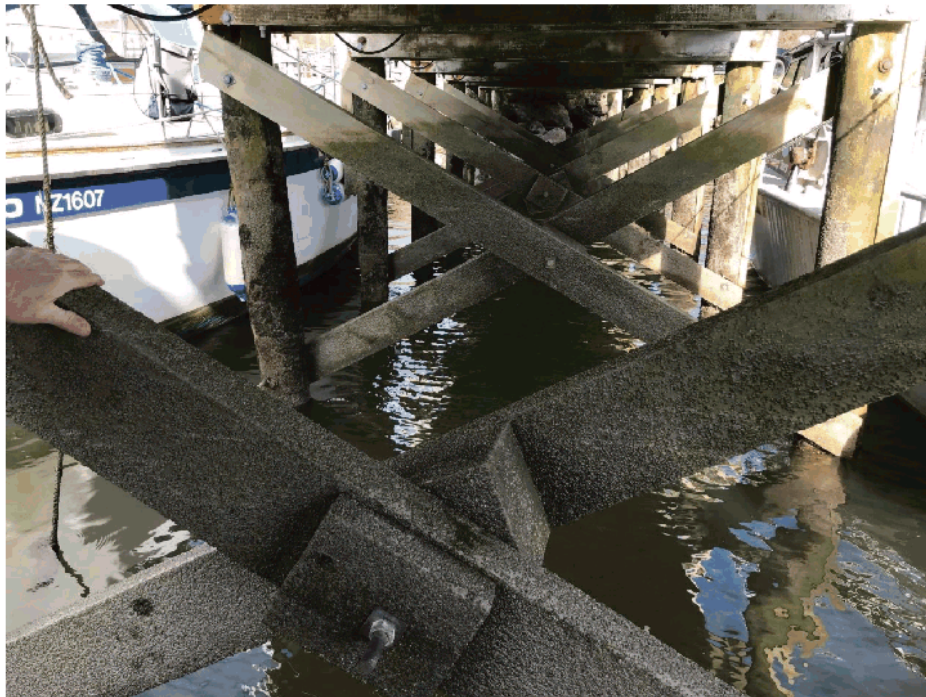
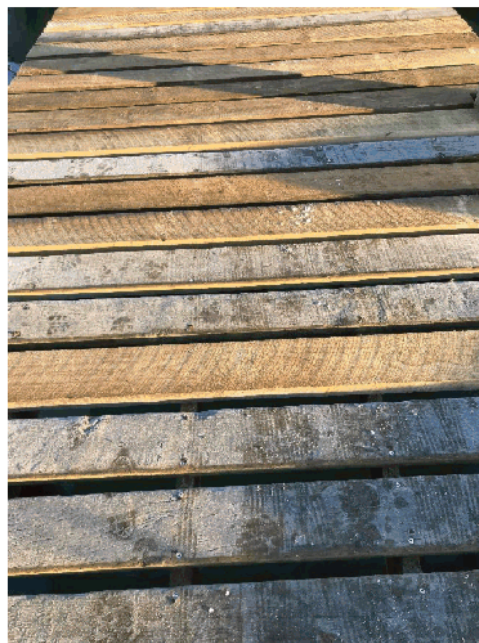
Asset or Berth Number	L22	Former Marine Department Reference:	MD 14661
Owners Name	J & K M Svensson		
Owners Address	57 Richard Street, Riverton 9822		
Asset Details	Asset type: Wharf structure (Part of Long Wharf)		
Lease Length (m)	17.23	Decking	200x50 SW
Structure Length (m)	17.23	Deck Beams	200x75 SW at 1.0m crs
Both sides Avail.	Yes	Headstocks	200x100 SW at 300 crs
Total Berthing (m)	34.46	Piles	200dia SW
Width (m)	3.05	Bracing	200x75 SW cross brace at all bents
Additional Areas	No	Fenders	3-100x50 landside
Services	Water & tap, Power cable	Bollards	No
Condition		Handrails	No
Deck	Decking has been replaced and all sound		
Structure	<p>A number of deck beams are showing significant loss of section or wasting. Outer deck beam riverside between bents 6 and 7 has been broken to the extent it does not reach the headstock</p> <p>The headstocks ends have degraded in some cases with the help of vessels belting rubbing them to the extent that it has exposed the bolt fastenings. Due to the fastenings' exposure they have then suffered accelerated corrosion.</p> <p>All outer fastenings near ends of headstocks or deck beams are showing signs of advanced corrosion</p>

Piles	All seven pairs of piles are sound		
Previous Recommendations	<p>Replace deck planks and general deck fastening.</p> <p>Deck beam at bents 6-7 to be replaced as soon as practical but within 6 months.</p> <p>Bolts in all headstocks need to be inspected and if exposed and seen to have advanced corrosion or noticeable loss of section they need to be replaced. Where fixing looks ok paint any exposed steel with 'Flintcoat' or similar bituminous paint.</p> <p>Bottom connections on all cross bracing at every bent have failed. Where failure is from bolt or degradation of existing brace is minor, brace can be lifted to slightly flatter angle and new fastening installed. Where the degradation is significant, the brace should be replaced in the short term of 6-12 months.</p>		
2018 Inspection	<p>Deck planking and fastenings have been replaced and are good. Selected deck beams have also been replaced where required. Additional bolt fastenings have been added where the existing were poor. All bracing and associated fastenings have been replaced.</p> <p>Recommend applying 'Flintcoat' or similar bituminous coating to all fastenings to ensure required durability is achieved.</p>

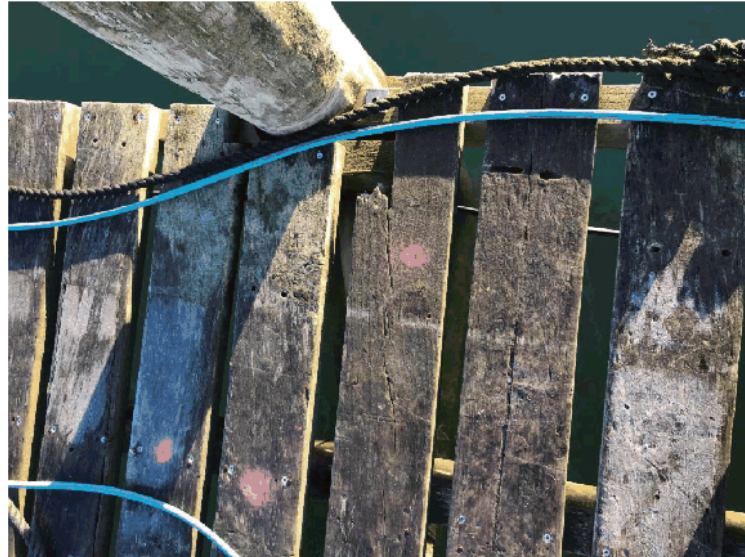
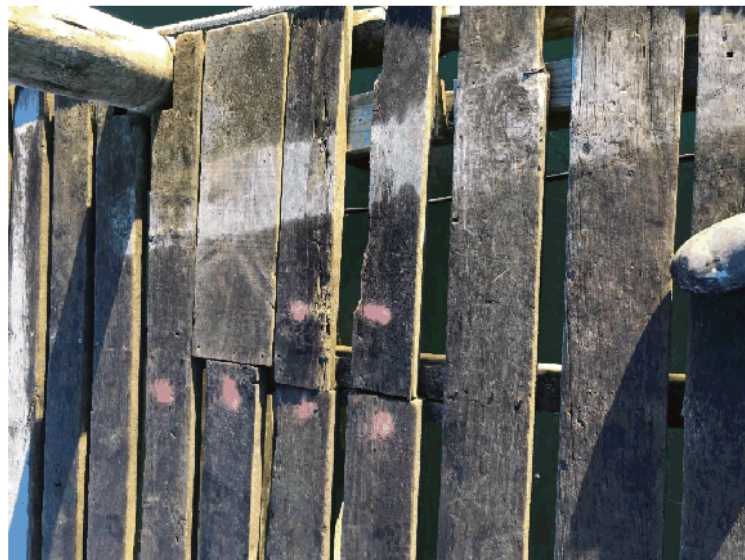
L24

2018 Inspection	<p>Identified deck planking and fastenings require replacement.</p> <p>All bracing and associated fastenings have been replaced.</p>

Additional bolt fastenings have been added where the existing were poor.
Recommend applying 'Flintcoat' or similar bituminous coating to all fastenings to ensure required durability is achieved.

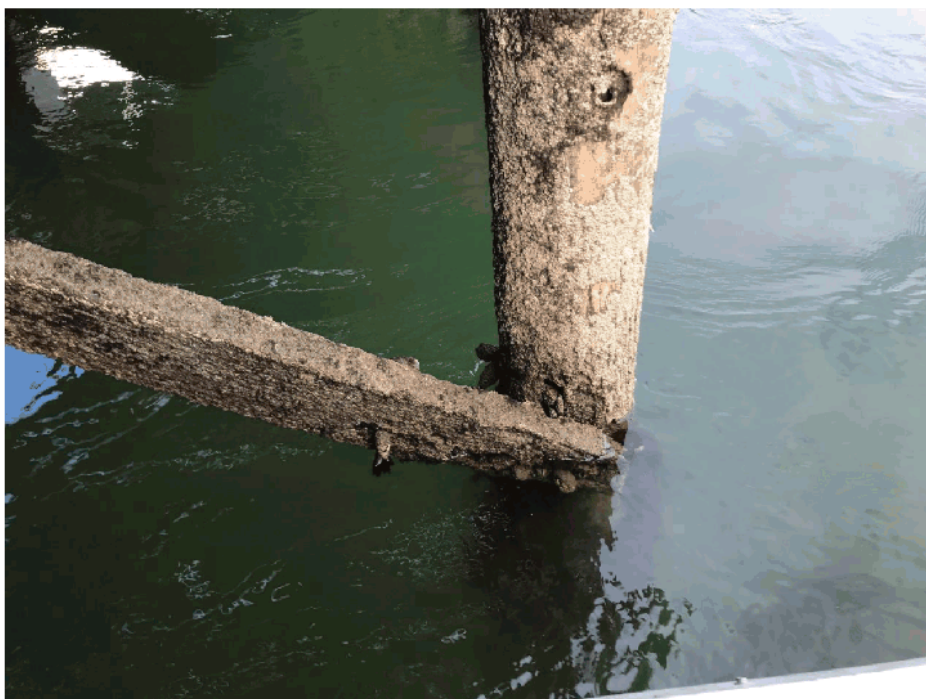
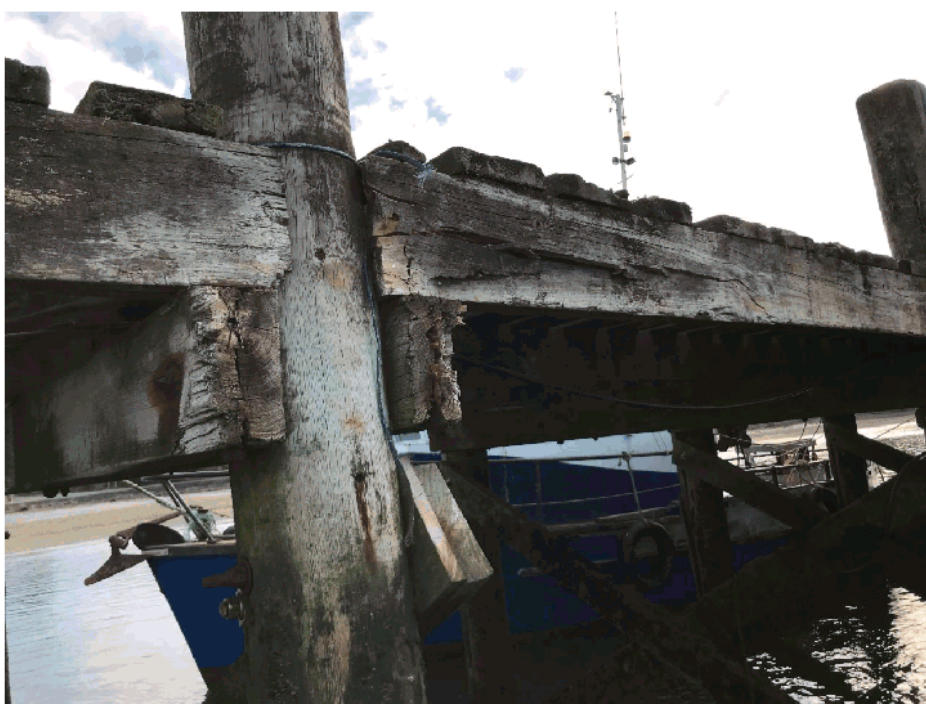
Asset or Berth Number	L26	Former Marine Department Reference:	MD 14665
Owners Name	Jones Family Trust		
Owners Address	c/- Dave Jones, 131 Layard St, Invercargill 9810		
Asset Details	Asset type: Wharf structure (Part of Long Wharf)		
Lease Length (m)	17.23	Decking	200x50 SW at 260crs
Structure Length (m)	17.23	Deck Beams	200x75 SW at 1.0m crs
Both sides Aval.	Yes	Headstocks	200x100 SW at 300 crs
Total Berthing (m)	34.46	Piles	200dia SW
Width (m)	3.05	Bracing	200x75 SW cross brace at all bents
Additional Areas	No	Fenders	2-75x75 landside 3-300x50 riverside
Services	Water & tap, Power cable	Bollards	No
Condition		Handrails	No
Deck	Deck generally sound with 1 plank requiring replacement and general deck plank fastening. Sections of deck bracing have failed and either disappeared or are hanging under deck ineffective		
Structure	The headstocks ends have degraded in some cases with the help of vessels belting rubbing them, to the extent that it has exposed the bolt fastenings. Due to the fastenings exposure they have then suffered accelerated corrosion. 1 outboard deck beam requires replacement as it appears to have been significantly damaged by an impact. 2 cross braces are unacceptable due to wastage and lower connections. All outer fastenings near ends of headstocks or deck beams are showing signs of advanced corrosion

Piles	All seven pairs of piles are sound. One pile has had the top broken off.		
Previous Recommendations	Replace deck plank and general deck fastening. As soon as practical provide blocking and covering timber for hole in the deck where pile was broken off Bolts in all headstocks need to be inspected and if exposed and seen to have advanced corrosion or noticeable loss of section they need to be replaced. Where fixing looks ok paint any exposed steel with 'Flintcoat' or similar bituminous paint. Bottom connections on all cross bracing at every bent have failed. Where failure is from bolt or degradation of existing brace is minor, brace can be lifted to slightly flatter angle and new fastening installed. Where the degradation is significant the brace should be replaced in the short term of 6-12 months.		
2018 Inspection	No maintenance or remedial works are obvious on this section of wharf since previous inspection. General deck planking and fixings are required to be carried out as well as the deck beam and cross bracing replacement

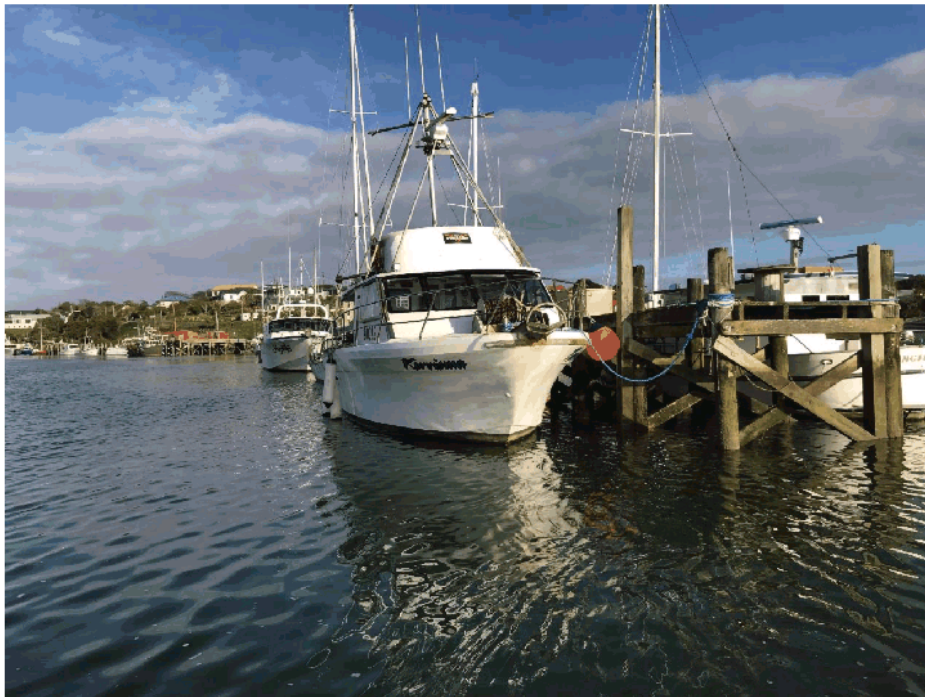
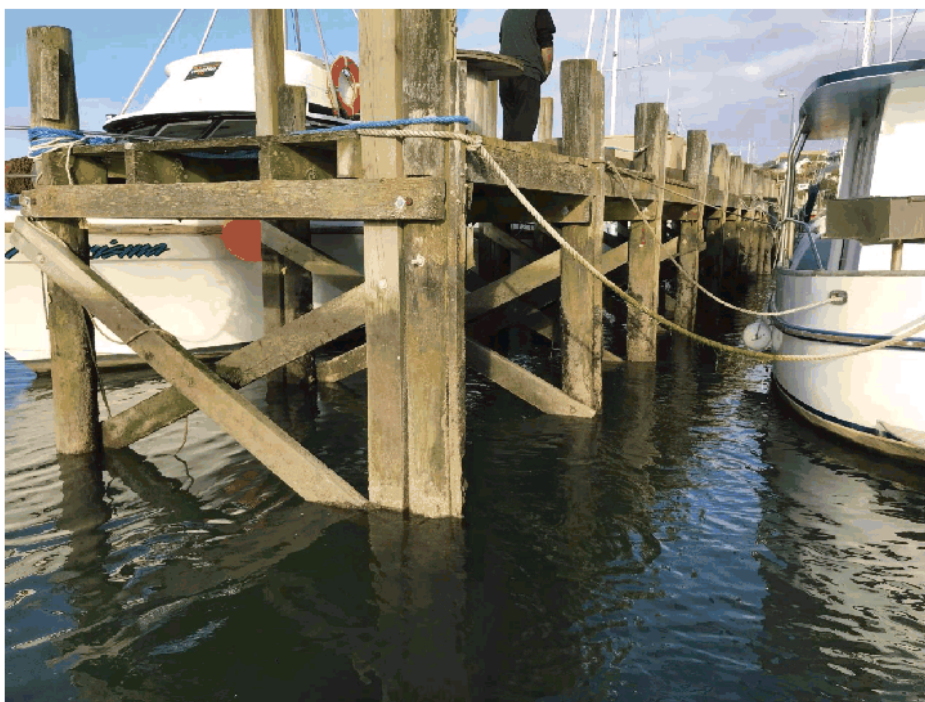
L30

Structure	The headstocks ends have degraded in some cases with the help of vessels belting rubbing it, to the extent that it has exposed the bolt fastenings. Due to the fastenings exposure they have then suffered accelerated corrosion. All outer fastenings near ends of headstocks or deck beams are showing signs of advanced corrosion		
Piles	All seven pairs of piles are sound. Outer most pile landside wasted		
Previous Recommendations	Replace deck planks and general deck fastening. Bolts in all headstocks need to be inspected and if exposed and seen to have advanced corrosion or noticeable loss of section they need to be replaced. Where fixing looks ok paint any exposed steel with 'Flintcoat' or similar bituminous paint. Bottom connections on all cross bracing at every bent have failed. Where failure is from bolt or degradation of existing brace is minor, brace can be lifted to slightly flatter angle and new fastening installed. Where the degradation is significant the brace should be replaced in the short term of 6-12 months. Investigate extent of pile wasting at outer most bent. If the loss of section exceeds 35% of original area, pile to be replaced within 3 months.

2018 Inspection	Some deck planking and fixings required Bracing has been addressed Outer pile has been doubled with the addition of 250x250sq SW pile

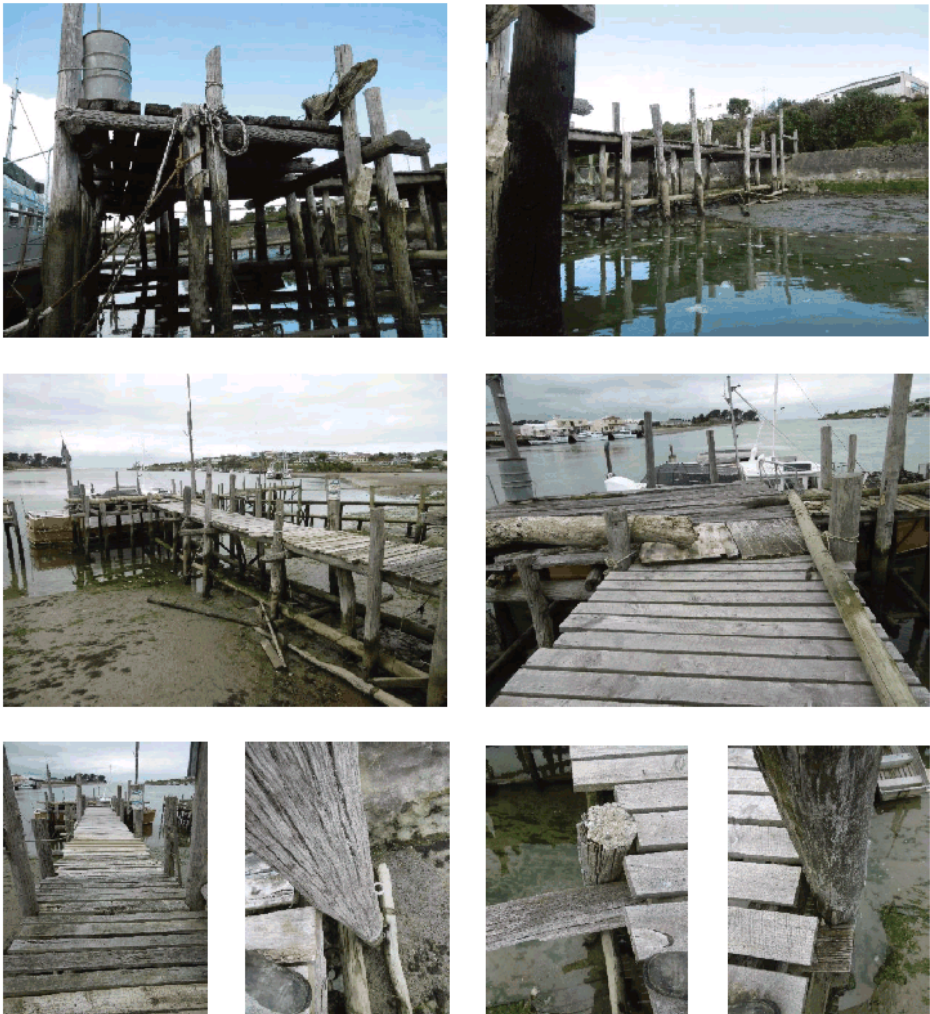
L37

Some form of cross bracing or similar approved to be installed on both the approach and the T-head.

All decking timber is required to be fixed down to the deck beams

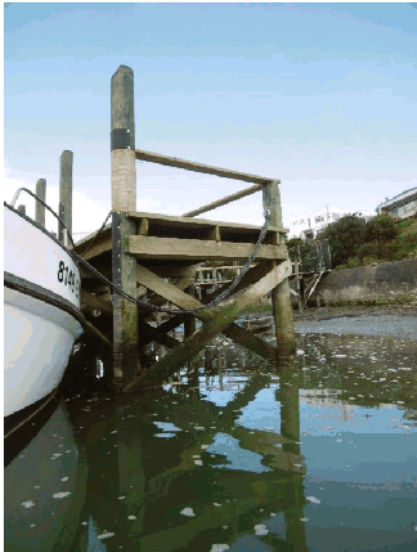
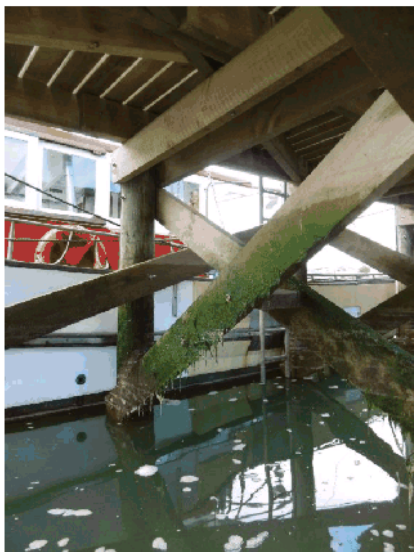
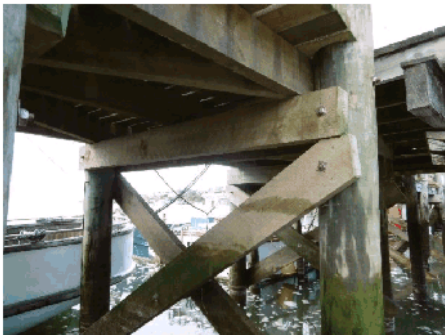
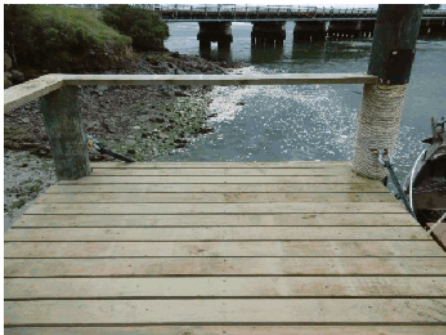
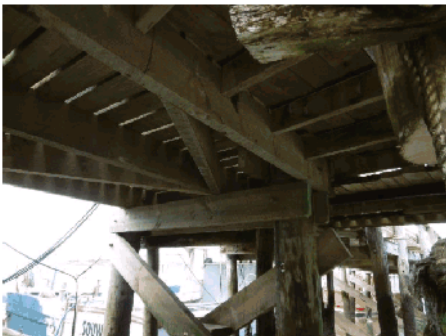
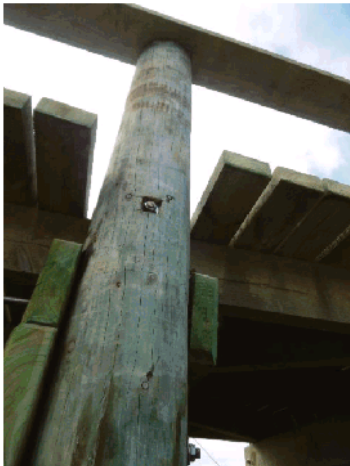
Asset or Berth Number	L39	Former Marine Department Reference:	-
Owners Name	Schofield Fishing Company Ltd, C/- Kevin Schofield		
Owners Address	508 Lorne Dacre Highway, RD 6, Invercargill 9876		
Asset Details	Asset type: Wharf structure (Continuation of L38)		
Lease Length (m)	12.5	Decking	150x75 SW at 180crs
Structure Length (m)	12.5	Deck Beams	250x75 at 1.25mcrs
Both sides Avail.	Yes	Headstocks	2-250x75
Total Berthing (m)	25.0	Piles	250 SED H6
Width (m)	2.1	Bracing	250x75 SW
Additional Areas	2.55 x2.55m platform and shed	Fenders	No
Services	No	Bollards	Extension of the piles
Condition		Handrails	250x75 railing to piles
Deck	New wharf structure, well-constructed.		
Structure	New wharf structure, well-constructed with the exception of the shed platform which forms an add-on to the wharf structure and is in an acceptable condition.		
Piles	New wharf structure, well-constructed.		
Additional info and comments

Previous Recommendations	Replace SW deck planks and handrails with bolted fixings (2-3 months) Replace or repair headstock with similar size treated timber and reinstate broken bracing including bottom fixing on others where required (3-6 months)		
2018 Inspection	Nil

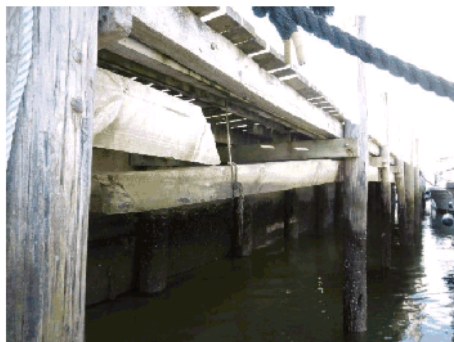
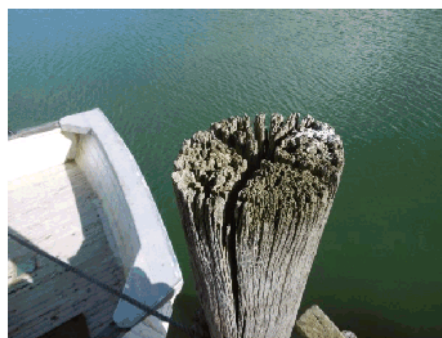
Asset or Berth Number	L40	Former Marine Department Reference:	MD 14565
Owners Name	Alistair and Raewyn Sutherland		
Owners Address	681 Manapouri Te Anau Highway TE ANAU 9679		
Asset Details	Asset type: Wharf structure		
Lease Length (m)	15.5	Decking	200x50
Structure Length (m)	15.5	Deck Beams	200x100 and 100x100 SW
Both sides Aval.	No	Headstocks	2-200x100 SW
Total Berthing (m)	15.5	Piles	400 oct. conc. Landside 200 SED riverside
Width (m)	3.1	Bracing	No
Additional Areas	No	Fenders	No
Services	Nil	Bollards	No
Condition	Handrails		No
Deck	The majority of the SW deck is acceptable with the exception of some planks at the upstream end. Some are badly cracked or have pieces broken out of and need to be addressed.		
Structure	Two beams are broken in the sub-structure and require replacement. The remainder of the timbers are adequate however the fixings are very badly corroded and some need to be replaced at pile/headstock connection.

Piles	Concrete piles are good. Timber berthing piles are showing both advanced cracking and degradation on their tops and noticeable wear from vessel beltings etc. and it is our recommendation that some sacrificial fender type timbers be attached to extend the life of the piles however this in its present condition does not affect the integrity of the pile.		
Additional info and comments	This wharf structure is a designated lease of a portion of a length of wharf referred to locally as the Co-op wharf. This section does not have any bracing but is well founded with tie-backs to the land from the concrete piles offering significant bracing support		
Previous Recommendations	Pile facings as above		
2018 Inspection	<p>No maintenance or remedial works are obvious since last inspection however a deterioration in the condition of the structure is noticeable.</p> <p>Broken beams in the sub-structure need to be addressed.</p> <p>Deck planking at the upstream end and outer edges needs to be fixed.</p>

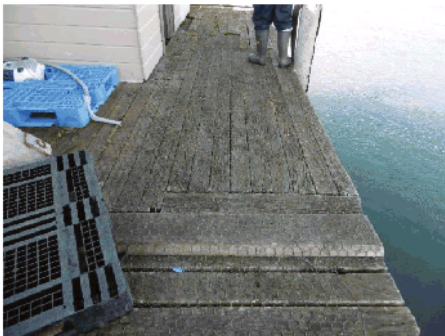
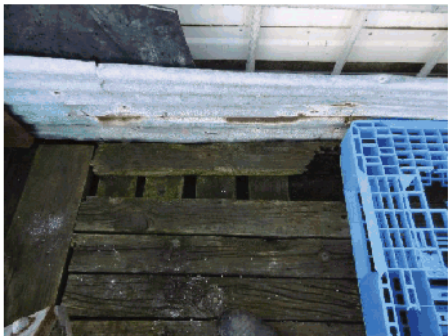
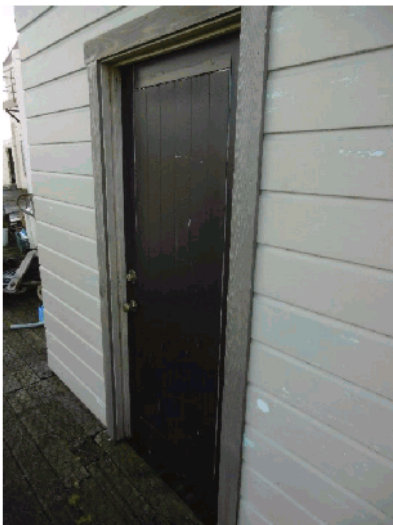
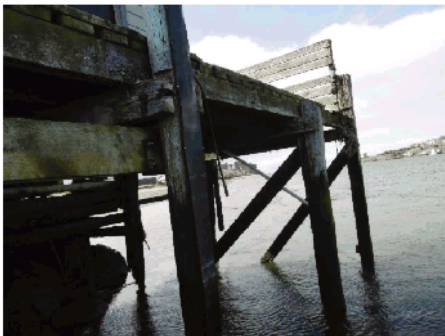
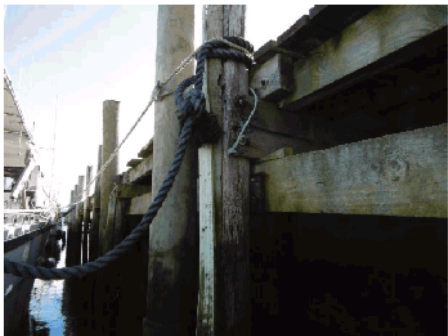
Asset or Berth Number	L43	Former Marine Department Reference:	MD 14656
Owners Name	C/- G Tong		
Owners Address	3521 Lorne-Dacre Highway, RD 6 Invercargill 9876		
Asset Details	Asset type: Wharf structure		
Lease Length (m)	10.0	Decking	200x50
Structure Length (m)	10.0	Deck Beams	200x100 and 100x100 SW
Both sides Avail.	No	Headstocks	2-200x100 SW
Total Berthing (m)	10.0	Piles	400 oct. conc. Landside 200 SED riverside
Width (m)	3.1	Bracing	No
Additional Areas	No	Fenders	No
Services	2.0 x 2.0m Shed	Bollards	No
Condition		Handrails	No
Deck	The SW deck is sound with secure fixings until the last 2m length at downstream end where light timber has been used to create an extension to the deck. Decking is poor in this area including in and around the shed. This creates multiple hazards.		
Structure	Structure is generally sound however there is a broken beam and a Headstock where the outer end has deteriorated back to the fixings and has failed. This has been chocked to the trimmer below which appears to have contributed to its fixings failing. This is unacceptable and needs to be rectified.

Piles	Both concrete and timber piles good. Timber berthing piles are showing wear from vessel beltings etc. and it is our recommendation that some sacrificial fender type timbers be attached to extend the life of the piles however this in its present condition does not affect the integrity of the pile.		
Additional info and comments	This wharf structure is a designated lease of a portion of a length of wharf referred to locally as the Co-op wharf. This section does not have any bracing but is well founded with tie-backs to the land from the concrete piles offering significant bracing support		
Previous Recommendations	Replace deficient decking at downstream end and make shed (fit door) secure to eliminate hazards created by the shed and its contents. (1-2 months)		
2018 Inspection	<p>Shed has been secured as per previous recommendation.</p> <p>Deck still requires remedial works at downstream end.</p> <p>Broken beams and failed headstock in the sub-structure need to be addressed.</p> <p>Steel carrier plates are extensively corroded and will require replacement in the short term</p>

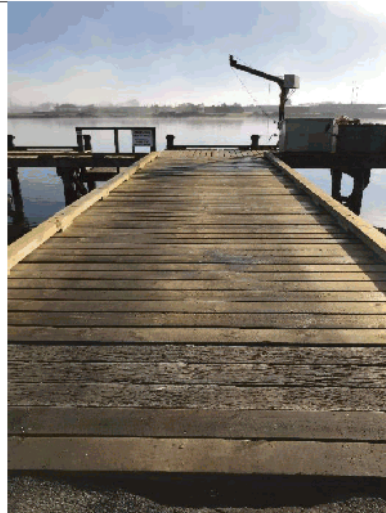
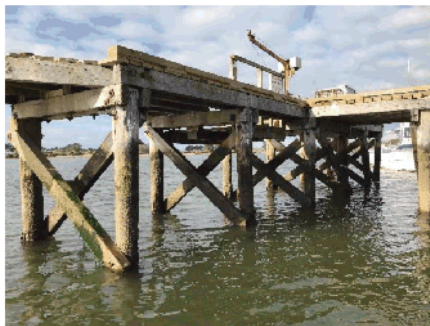
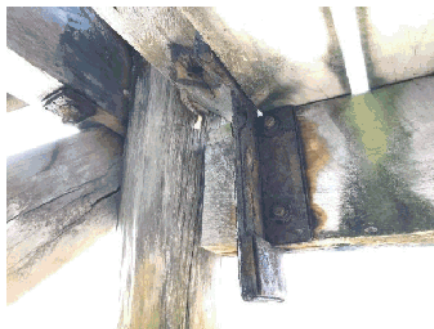
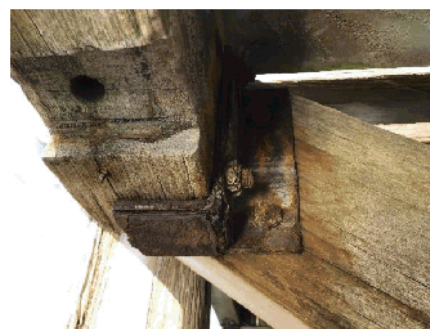
T-Wharf

Kerb block at landward end requires solid fixing.

Badly corroded steel brackets and fastenings require immediate attention.
