Riverton Harbour Subcommittee Agenda OPEN

- 1 The purpose of the report is to provide the Riverton Harbour Subcommittee (RHS) with an update on the second Emtech report on the Riverton Harbour wharves. This report covers the level of maintenance that has been undertaken to bring the wharves up to the required standard since the first report was provided to wharf owners in November 2015.
- 2 Further, this report seeks the RHS recommendation to Council that should current licence holders fail to complete the necessary works by 30 June 2019 Council will move to revoke licences and ownership.

On 4 and 5 September 2018 Emtech personnel assisted by Riverton Community Board (RCB) representatives carried out re-inspections on all the structures for which SDC in conjunction with the Riverton Harbour Subcommittee (RHS) have jurisdiction for permitting and licensing. These inspections were undertaken to assess the current condition of the structures and in particular if the recommended maintenance works following the 2014 inspections had been addressed.

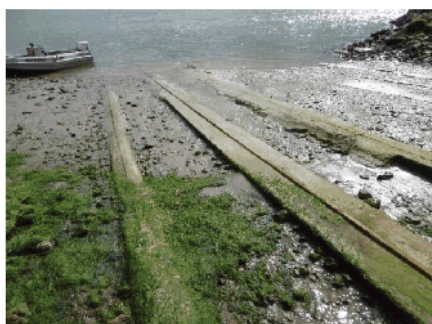
L01

2018 Inspection	Erosion areas around rails have been addressed. No coffer dams installed to limit future erosion but acceptable as current. The machinery/gear room is not secure. The owner was present at time of inspection and communicated that the door and openings were for a purpose due to equipment in shed. While we appreciate that the openings in door and front of shed for cable are there for operational purposes, these should be able to be closed and secured when not in use. This area is readily accessible by public. EL expect that this would not be acceptable to either SDC or the owners HSWA requirements.

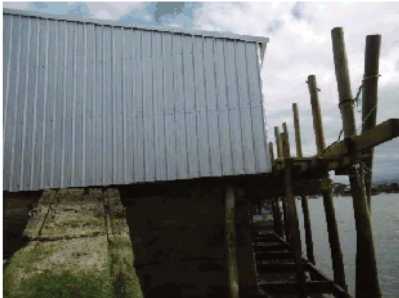
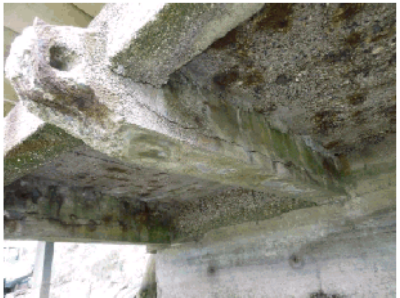
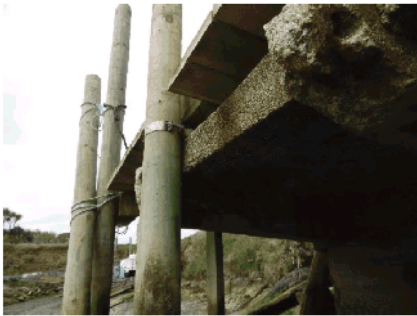
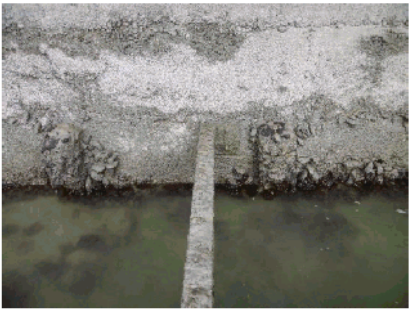
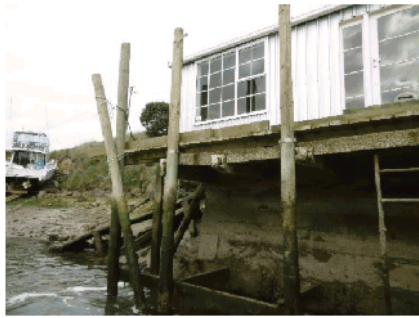
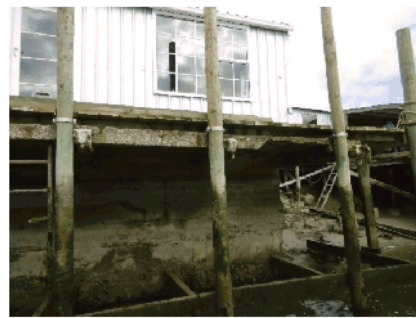
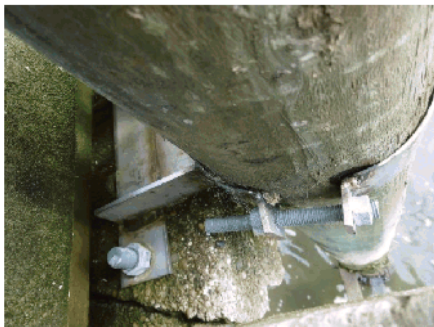
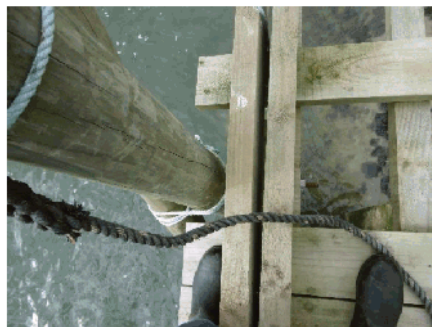
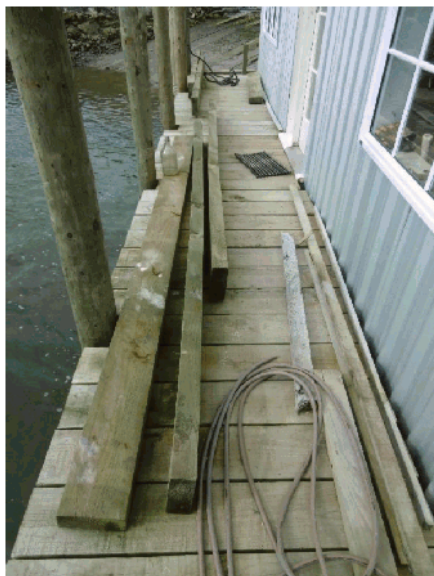
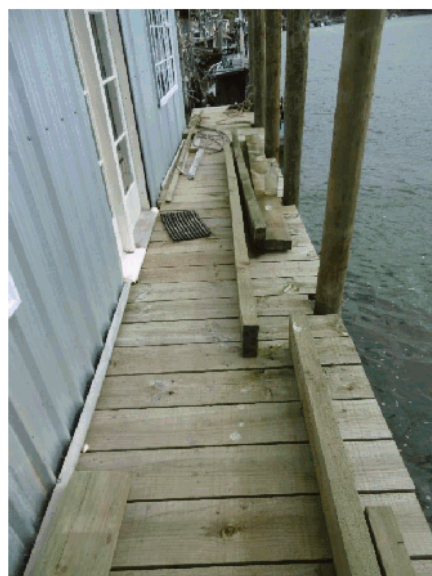
L03

We have significant concern regarding the cantilevered concrete deck which is showing signs of advanced corrosion, spooling and cracking and its ability to continue to support the deck as this deterioration advances. We recommend an engineer's report on its suitability to continue to support the deck or an engineer's statement or engineered solution providing adequate additional means of support.

Decking needs installed at downstream end and handrailing is required at both deck ends on non-berthing faces

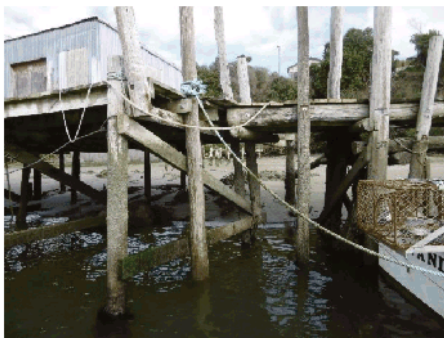
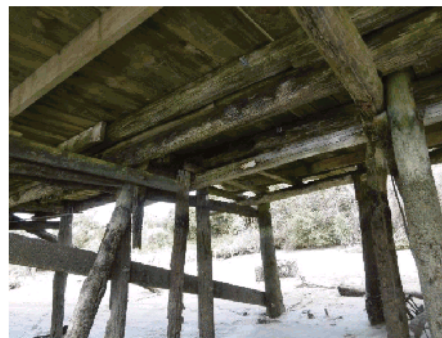
L12

A number of required fixings in beams and headstocks have been addressed.

Braces fixed to multiple piles have been installed transversely and are providing adequate bracing now

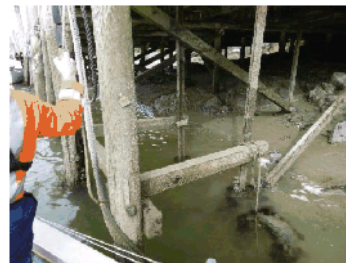
Piles	All except 2 of the HW piles are satisfactory and all railway iron piles at upstream end are also satisfactory.		
Additional info and comments	Shed: 2.8 x 2.6m. Has had an internal fire with walls and roof framing at one end badly damaged. Remaining walls, roof and floor appear sound.		
Previous Recommendations	<p>General nailing of deck planking and replacement of the two split, wasted and broken piles to be completed within 6-12 months.</p> <p>Refer photo over for location. Ensure when replacing piles all bracing is reinstated.</p>		
2018 Inspection	3 Piles have been replaced and fixings have been replaced as required.

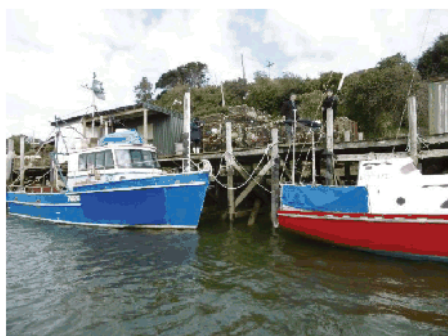
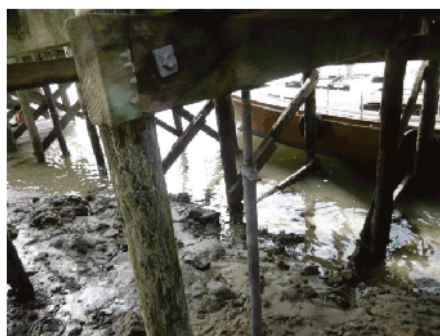
Asset or Berth Number	L15	Former Marine Department Reference:	MD(S)148
Owners Name	JM & LS Gibbs		
Owners Address	34 Brook Street, Riverton 9822		
Asset Details	Asset type: Wharf structure and Shed		
Lease Length (m)	13.84	Decking	Mixture 200x50 SW (majority) and HW
Structure Length (m)	13.71	Deck Beams	200x75 @ 1m crs nom HW
Both sides Avail.	No	Headstocks	200x75 SW
Total Berthing (m)	13.71	Piles	Mixture 200dia SW/HW @ 2m crs
Width (m)	Varies	Bracing	200x100
Additional Areas	Approach: Landward 5.85m (L) x 1.4m (W) widens to 2.85m (L) x 2.5 (W) Shed: 3.7m x 2.15m		
Services	Water and 1 wharf tap	Fenders or Bollards	No
Condition		Handrails	Removed
Deck	Decking (majority SW) now satisfactory on both wharf and approach		
Structure	All 6 pile bents over the length of this structure have braces fitted and all now have satisfactory upper and lower connections. Headstocks and deck beams are all sufficient. A few lower walers are wasted but do not demand immediate attention.

Piles	6 pairs on wharf plus 3 pairs on approach all ok		
Additional info and comments	Handrail section on wharf in poor condition. This will require upgrading if it is to remain		
Previous Recommendations	Replace deck planks on approach and reinstate bracing on two upstream bents. This may be as simple as lifting the brace at the bottom connection and fastening with new 20dia galv bolts. Using larger diameter bolts and 50x50 min washers decreases the wood fibre crushing experienced with smaller diameter bolts and washers and increases durability of connection		
2018 Inspection	Bracing has been addressed on main wharf and approach timbers are now satisfactory.

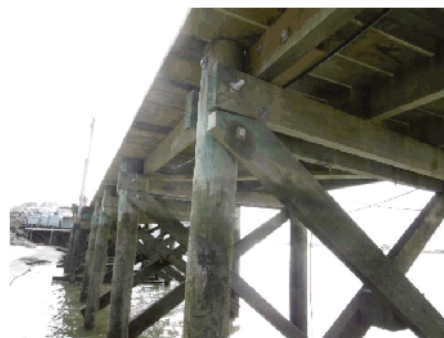
L16

2018 Inspection	Only recommendation would be to apply some bituminous or approved mastic coating to all bolt heads, nuts and washers to ensure you get the required durability. Good installation

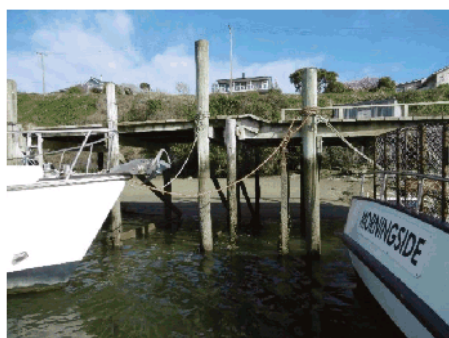
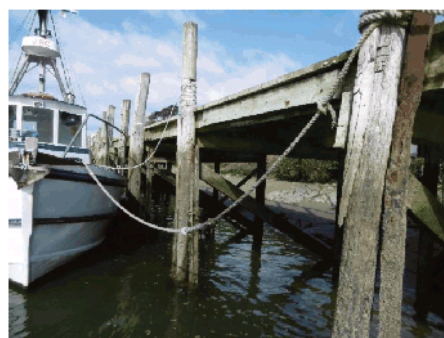
Asset or Berth Number	L18	Former Marine Department Reference:	MD12643
Owners Name	SW & M MacDonald		
Owners Address	33 Alamein Street, Riverton 9822		
Asset Details	Asset type: Wharf structure		
Lease Length (m)	15.26	Decking	150x50 SW at 200 crs
Structure Length (m)	15.23	Deck Beams	250x50 SW at 1400 crs
Both sides Avail.	N0	Headstocks	Railway irons and softwood - Poor
Total Berthing (m)	15.23	Piles	2 x 200 and 2x250 – landside
Width (m)	3.2m	Bracing	200x75 and 200x100 SW
Additional Areas		Fenders	Four berthing piles have SW fender extensions above top of pile
Services	Water and 1 tap	Bollards	No
Condition		Handrails	No
Deck	The decking condition varies greatly from new planks to very poor. The current deck is serviceable but requires general refastening of deck planks and a minimum of three planks require replacement.		
Structure	The original sub-deck structure appears to have been braced pairs of railway iron piles with railway iron headstocks and bracing. This type of construction only remains at the downstream end. We understand the wharf at time of inspection was in the process of being upgraded with new treated SW piles with bracing already installed in some areas. The remaining railway irons are in very poor condition and require replacement.

Piles	The newly installed piles are good and the remaining piles are poor with considerable deterioration and joint fastenings very poor.		
Previous Recommendations	Replace all railway iron members with treated SW timber piles, headstocks bracing and beams in short term 6-12 months All new members to be connected with galv. 20mm bolts and 50x50 washers General deck fixings and replacement of deck planks – in short term		
2018 Inspection	All above recommendations have been addressed

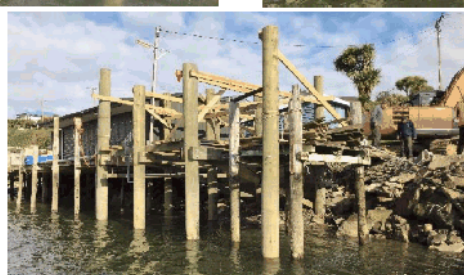
Asset or Berth Number	L20	Former Marine Department Reference:	-
Owners Name	Southern Protein Limited, Russell Keen		
Owners Address	PO Box 19, Stewart Island 9846		
Asset Details	Asset type: Wharf structure and Shed		
Lease Length (m)	9.53	Decking	200x75 at 210mm crs
Structure Length (m)	9.53	Deck Beams	300x100 at 600mm crs
Both sides Aval.	No	Headstocks	2x300x100
Total Berthing (m)	9.53	Piles	250SED HW at 2.9m nom.
Width (m)	2	Bracing	200x75
Additional Areas	4.3 x 2.4m approach	Fenders	No
Services	Power, water & wharf tap	Bollards	No
Condition		Handrails	No
Deck	Existing wharf removed, new treated SW structure		
Structure	Existing wharf removed, new treated SW structure		
Piles	Existing wharf removed, new treated SW structure		
Additional info and comments	Under construction at time of inspection – Progress to date was well built		
Recommendations	Nil

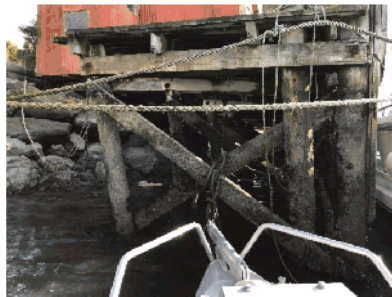
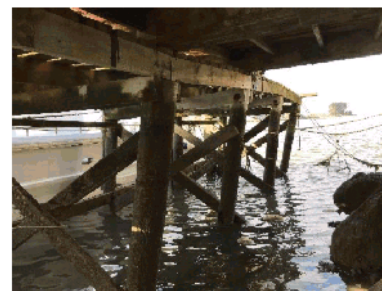
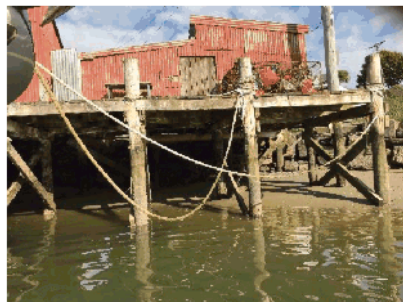
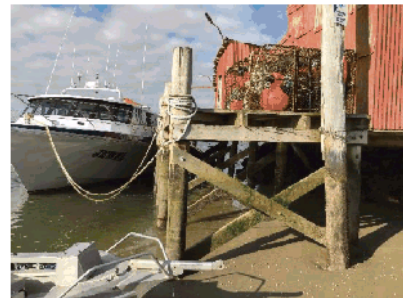
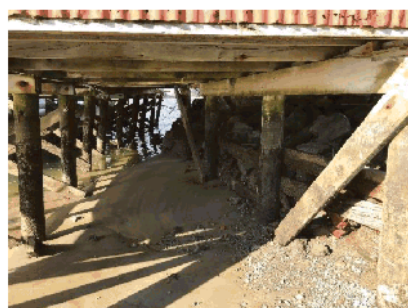
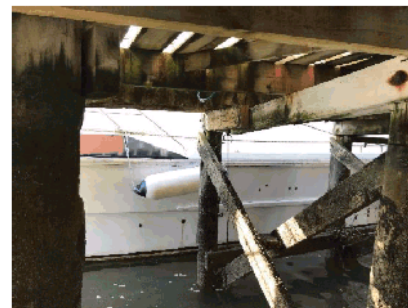
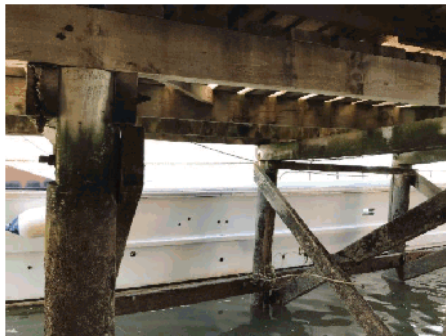
L21

Other beams are broken or cracked, and the structure has begun to slump noticeably as the toes of the outer piles appear have settled outboard. This settlement exacerbated obviously by a larger boat impacting higher up the fender piles is putting the structure under stress and is most certainly contributing to the cracking and broken timbers.

A high percentage of the fixings around bracing and headstock to pile connections are very badly corroded and will also require replacement.

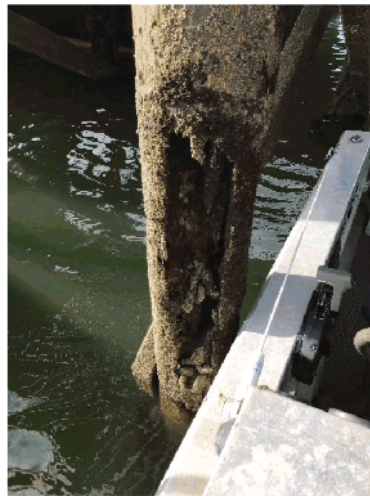
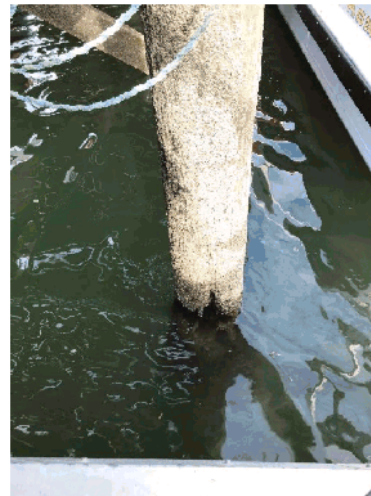
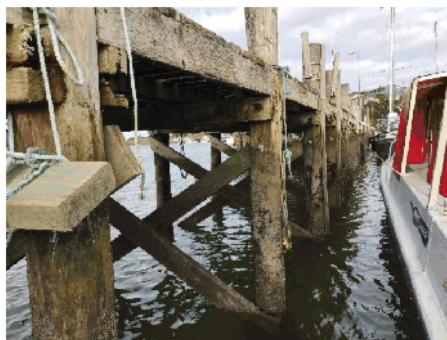
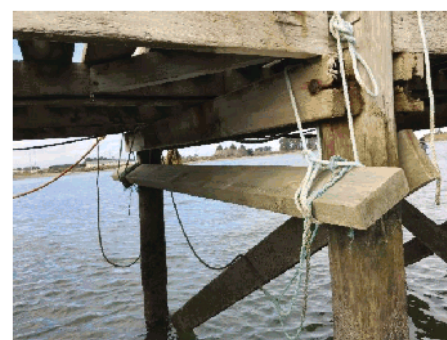
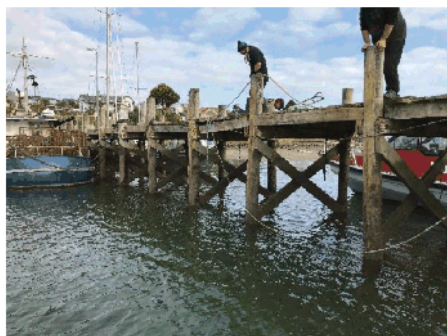
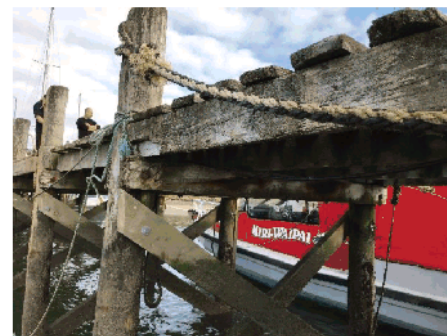
Asset or Berth Number	L25	Former Marine Department Reference:	MD 14664
Owners Name	R T Bull		
Owners Address	32 Walker Street, Riverton 9822		
Asset Details	Asset type: Wharf structure (Part of Long Wharf)		
Lease Length (m)	17.23	Decking	200x50 SW at 260crs
Structure Length (m)	17.23	Deck Beams	200x75 SW at 1.0m crs
Both sides Aval.	Yes	Headstocks	200x100 SW at 300 crs
Total Berthing (m)	34.46	Piles	200dia SW
Width (m)	3.05	Bracing	200x75 SW cross brace at all bents
Additional Areas	No	Fenders	1-125x75 landside
Services	Water & tap, Power cable	Bollards	No
Condition		Handrails	No
Deck	General deck plank fastening required. Sections of deck bracing have failed and either disappeared or are hanging under deck ineffective		
Structure	4 deck beams on the outboard side require replacement as a minimum. The headstocks ends have degraded in some cases with the help of vessels belting rubbing them, to the extent that it has exposed the bolt fastenings. Due to the fastenings exposure they have then suffered accelerated corrosion. All outer fastenings near ends of headstocks or deck beams are showing signs of advanced corrosion

Piles	Of the six pairs of piles, 10 are sound and 2 have significant defects and will require replacing. Bent 24 was mistakenly catalogued under L24 which has a significantly wasted pile.		
Previous Recommendations	Replace deck planks and general deck fastening. Bolts in all headstocks need to be inspected and if exposed and seen to have advanced corrosion or noticeable loss of section they need to be replaced. Where fixing looks ok paint any exposed steel with 'Flintcoat' or similar bituminous paint. Bottom connections on all cross bracing at every bent have failed. Where failure is from bolt or degradation of existing brace is minor, brace can be lifted to slightly flatter angle and new fastening installed. Where the degradation is significant the brace should be replaced in the short term of 6-12 months.		
2018 Inspection	Very little has been done to this section of wharf since previous inspection. A minimum of 2 piles, 4 deck beams, multiple bolt fixings and decking planks are required to be addressed. SDC has been advised these works are underway but were not completed at time of inspection

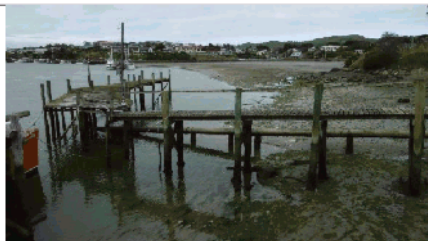
Additional info and comments	The L35 structure is of serious concern and while vessels are still using it, there is a very real risk in adverse condition that this structure could fail. The doubtful integrity of the structure and the security of vessels moored to it justify urgent action on the part of SDC.		
Previous Recommendations	<p>If this structure is to be repaired there is very little to be recovered from the existing structure and the project would more resemble a rebuild from scratch requiring at least 10 min new piles, headstocks, deck beams, decking and associated fixings. It is recommended that the owners be required to present a programme for repair or replacement within 2 months. The plan to be subject to approval by SDC with the intention to restore the structure to an acceptable level within 6 months of approval being granted, at which time a further inspection will be made.</p> <p>The continued validity of the licence to occupy sea bed to be conditional upon compliance with the above</p>

2018 Inspection	No maintenance or remedial works have been undertaken on this structure since the previous inspection

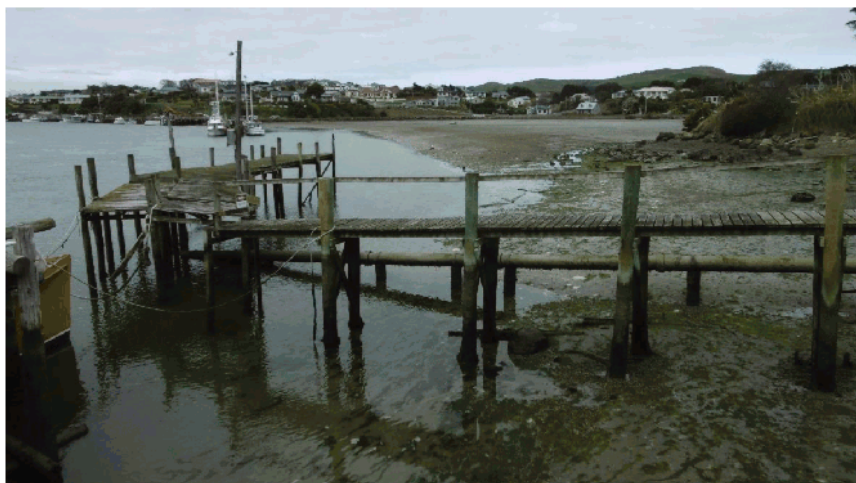
Structure	The structure of L36 is poor. Approximately 50% of the headstocks are unacceptable with a similar percentage of deck beams also unacceptable and all bracing is broken or gone.		
Piles	The piles show wasting at low water, and while not as dramatic as the adjacent wharf some have significant loss of effective diameter and with no bracing present, offer little in lateral resistance. This part of the wharf has 3 lines of piles and therefore is a little more robust. The connections to the headstocks appear ok		
Additional info and comments	A wharf of two halves, approach good, wharf poor.		
Previous Recommendations	<p>The approach requires no remediation other than at the outer end its connection to the wharf would need to be addressed with any repairs. The wharf decks, lower area in particular and at the junction with the approach are very poor and decking would require complete replacement. On the upper deck 20-30% of the decking planks would require replacement. Where headstocks are showing signs of advanced deterioration a new treated headstock of similar size should be bolted on the other side of the piles.</p> <p>Deck beams will need to be replaced on a case by case basis once decking is removed and condition can be properly assessed but EL estimate as much as 30-40% of these would require replacement.</p> <p>With the addition of heavy fender type timber bolted to the piles ensuring it spans the wasted area and fixed both sides and the addition of 150x75min</p>

cross bracing it would provide this structure with an economical repair offering an acceptable remaining life for a structure in this condition.

No maintenance or remedial works have been undertaken on this structure since the previous inspection

Piles showing loss of section of more than 35% of original should be replaced within 3 months,

It is recommended that the owners be required to present a programme for repair or replacement within 2 months. The plan to be subject to approval by SDC with the intention to restore the structure to an acceptable level within 6 months of approval being granted, at which time a further inspection will be made.

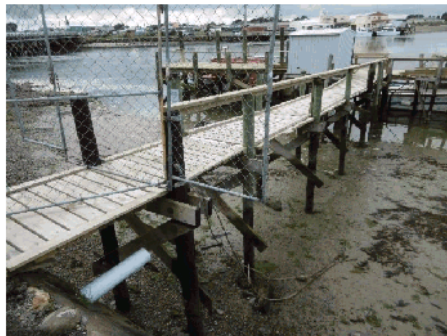
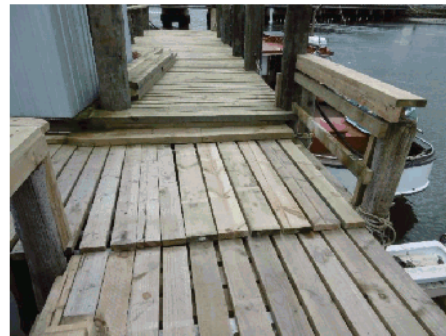
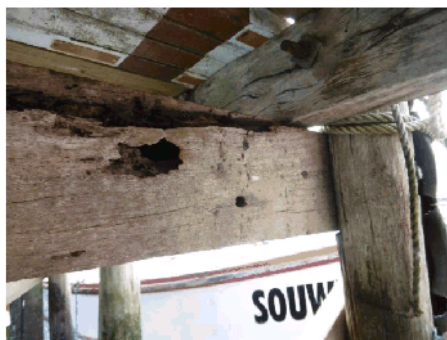
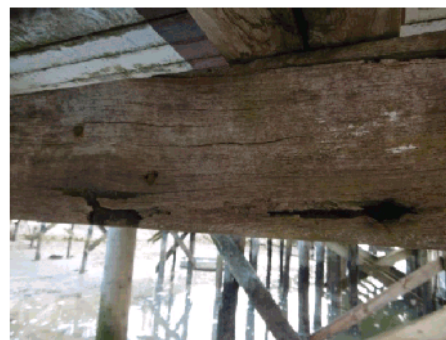
Asset or Berth Number	L38	Former Marine Department Reference:	MD 12642
Owners Name	E W Dickson		
Owners Address	361 Orepuki-Riverton Highway, Riverton 9822		
Asset Details	Asset type: Wharf structure		
Lease Length (m)	11.5	Decking	New 150x50 treated SW over existing deck
Structure Length (m)	11.5	Deck Beams	200x100 HW
Both sides Aval.	No	Headstocks	200x100 HW
Total Berthing (m)	11.5	Piles	150dia HW
Width (m)	2.1	Bracing	200x50 SW
Additional Areas	18.8 x 1.6m Approach	Fenders	No
Services	No	Bollards	No
Condition		Handrails	Yes - New
Deck	The approach decking has been completely renewed from road to T-head complete with kerb or kick rail both sides and hand rail downstream side only. Wharf head decking is new 150x50 treated SW planking fixed over existing deck.		
Structure	<p>The Headstocks on the wharf are sound except one, the second last downstream bent. This headstock is compromised by rot from the top of the member and will require replacement.</p> <p>As the piles are relatively small diameter it is important that adequate levels of bracing are maintained. The majority of bracing is in adequate condition with one broken brace requiring replacement and one requiring reinstatement of adequate bottom fastening</p> <p>Approach structure has been recently upgraded and is sound.</p>

Piles	<p>Piles on the wharf structure are light HW poles and show signs of wasting at lower water level. While this is concerning, if adequate effective bracing is maintained at all times and the pile wasting does not accelerate these piles can be accepted as adequate in the short term. A replacement strategy should be initiated for the medium term (3-5 years)</p> <p>Approach piles all sound</p>		
Additional info and comments	Works were on-going at time of inspection with SDC notified of pending arrival of timber for additional bracing on out board piles.		
Previous Recommendations	<p>Replace SW deck planks and handrails with bolted fixings (2-3 months)</p> <p>Replace or repair headstock with similar size treated timber and reinstate broken bracing including bottom fixing on others where required (3-6 months)</p>		
2018 Inspection	<p>Wharf was much improved on last inspection.</p> <p>2 downstream headstocks are significantly deteriorated and will require replacement or duplication with new on other side of pile if possible.</p> <p>Bracing is required to be installed to form cross on a minimum of three bents. We understand the installation is pending arrival of treated timber.</p>

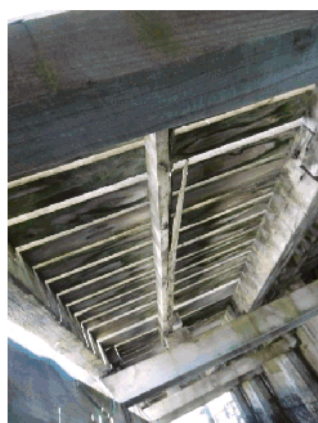
Asset or Berth Number	L40	Former Marine Department Reference:	MD 14565
Owners Name	Alistair and Raewyn Sutherland		
Owners Address	681 Manapouri Te Anau Highway TE ANAU 9679		
Asset Details	Asset type: Wharf structure		
Lease Length (m)	15.5	Decking	200x50
Structure Length (m)	15.5	Deck Beams	200x100 and 100x100 SW
Both sides Aval.	No	Headstocks	2-200x100 SW
Total Berthing (m)	15.5	Piles	400 oct. conc. Landside 200 SED riverside
Width (m)	3.1	Bracing	No
Additional Areas	No	Fenders	No
Services	Nil	Bollards	No
Condition	Handrails		No
Deck	The majority of the SW deck is acceptable with the exception of some planks at the upstream end. Some are badly cracked or have pieces broken out of and need to be addressed.		
Structure	Two beams are broken in the sub-structure and require replacement. The remainder of the timbers are adequate however the fixings are very badly corroded and some need to be replaced at pile/headstock connection.

Piles	Concrete piles are good. Timber berthing piles are showing both advanced cracking and degradation on their tops and noticeable wear from vessel beltings etc. and it is our recommendation that some sacrificial fender type timbers be attached to extend the life of the piles however this in its present condition does not affect the integrity of the pile.		
Additional info and comments	This wharf structure is a designated lease of a portion of a length of wharf referred to locally as the Co-op wharf. This section does not have any bracing but is well founded with tie-backs to the land from the concrete piles offering significant bracing support		
Previous Recommendations	Pile facings as above		
2018 Inspection	<p>No maintenance or remedial works are obvious since last inspection however a deterioration in the condition of the structure is noticeable.</p> <p>Broken beams in the sub-structure need to be addressed.</p> <p>Deck planking at the upstream end and outer edges needs to be fixed.</p>

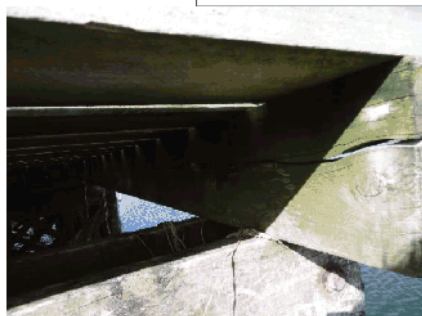
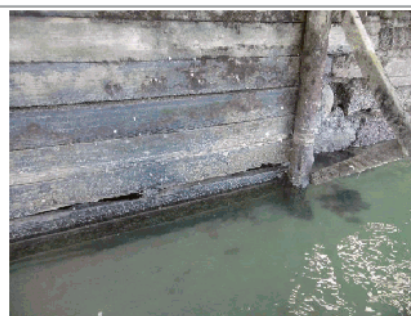
Asset or Berth Number	L44	Former Marine Department Reference:	
Owners Name	W B Corbin		
Owners Address	84 Milton Street, RIVERTON 9822		
Asset Details	Asset type: Wharf structure		
Lease Length (m)	9.11	Decking	200x50 SW
Structure Length (m)	9.11	Deck Beams	200x50 SW
Both sides Aval.	No	Headstocks	2-200x50 SW
Total Berthing (m)	9.11	Piles	150dia HW
Width (m)	3.1	Bracing	100x50 SW
Additional Areas	No	Fenders	No
Services	Nil	Bollards	No
Condition	Handrails		No
Deck	The SW deck is sound with secure fixings		
Structure	<p>This structure has defects that need to be remedied outlined below:</p> <p>The outside upstream deck beam is split and is ineffective as a structural member. This needs to be replaced urgently.</p> <p>All braces are either broken or connections have failed and these need to be reinstated as soon as practical to ensure this structure is able to perform as required.</p>		
Piles	All ok		
Additional info and comments	This structure is not for permanent berthing but is used generally for loading and unloading personnel when using the boat ramp etc. It is also situated in a high current area and is frequently subject to high berthing loads. Structural integrity in the form of good connections and braces should be maintained at all times

Previous Recommendations	Outer deck beam and bracing requires reinstatement with treated timber members of equal size to those existing as soon as practical (1-2 months)		
2018 Inspection	<p>Decking has been replaced and is all well secured.</p> <p>Upstream deck beam has not been replaced and is required.</p> <p>L44 still does not have any effective cross bracing and this should also be a priority.</p>

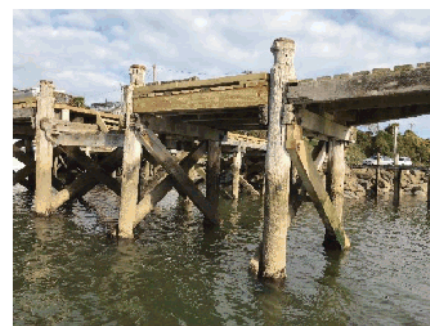
T-Wharf

Structure	<p>The structure is very solidly built with HW, and while the HW is very weathered, it is generally in good serviceable condition with only minor defects outlined below:</p> <p>Many of the fastenings are now suffering from advanced corrosion. An assessment of critical fastenings should be undertaken and were required these be replaced.</p> <p>Diagonal brace timber on the approach and central cross wharf is in an acceptable condition but the bolt fixings are badly corroded and require immediate attention in some cases.</p> <p>Diagonal bracing on the outer ends of the cross wharf is new however the timber has shrunk, or the bolts have come loose and require re-tightening</p>		
Piles	All are generally ok just with advanced degradation at the bollard tops.		
Additional info and comments			
Previous Recommendations	<p>Bracing elements requires reinstatement with new fixings if possible or if a brace requires full replacement, H6 treated timber members of equal size to those existing should be used (3-6 months)</p> <p>Decking timber replacement and fastening assessment should also be completed in 3-6 months</p>

Decking has been replaced as required and is generally well secured. Some decking needs to be addressed on the lower boarding platform.

Kerb block at landward end requires solid fixing.

Badly corroded steel brackets and fastenings require immediate attention.
